Summary Comparison of IAQ Microbiological Test Results at:

PETROSAINS Sdn Bhd,  
4<sup>th</sup> Floor, Petronas Twin Towers,  
Level 4, Suria KLCC, 50088 Kuala Lumpur

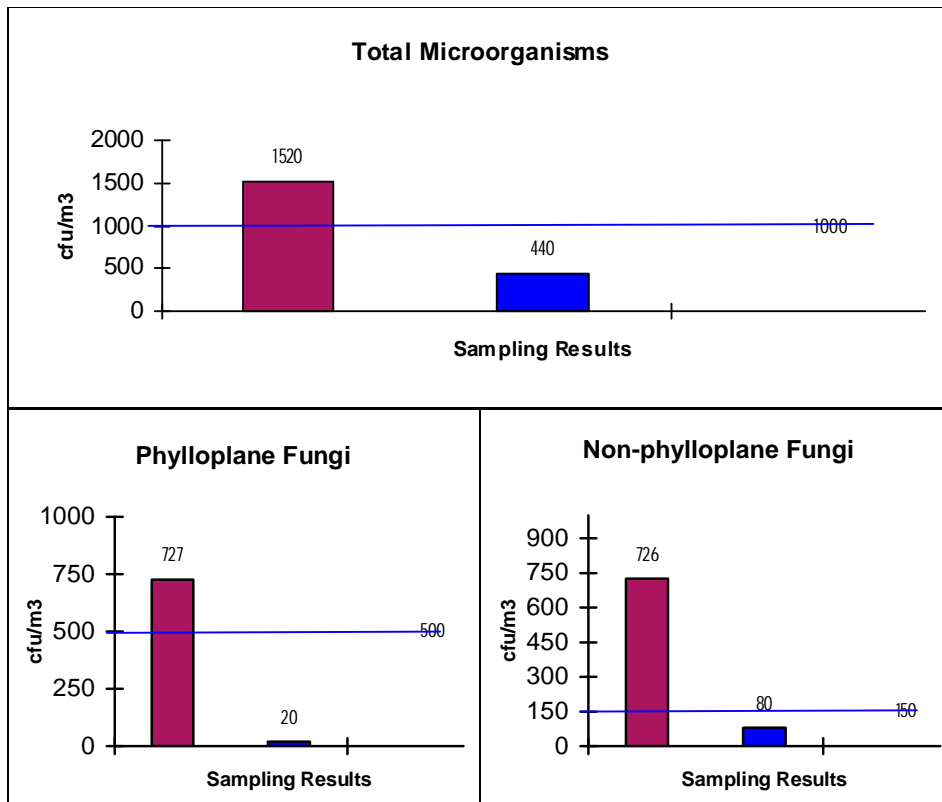
Location 1: Counting Room (OUTSIDE), Finance Dept. 4<sup>th</sup> Floor.

Colony forming units per cubic meter of Air (cfu/m <sup>3</sup> )	Guideline limit (cfu/m <sup>3</sup> )	Previous results (sample date 4/11/04)	Re-test sampling results (sample date 15/2/06) Readings made 3 wks after Airfree's installation.	Percentage reduction
Total Microorganisms	1000	1520	440	71%
Phylloplane Fungi	500	727	20	97%
Non-phyloplane Fungi	150	726	80	89%

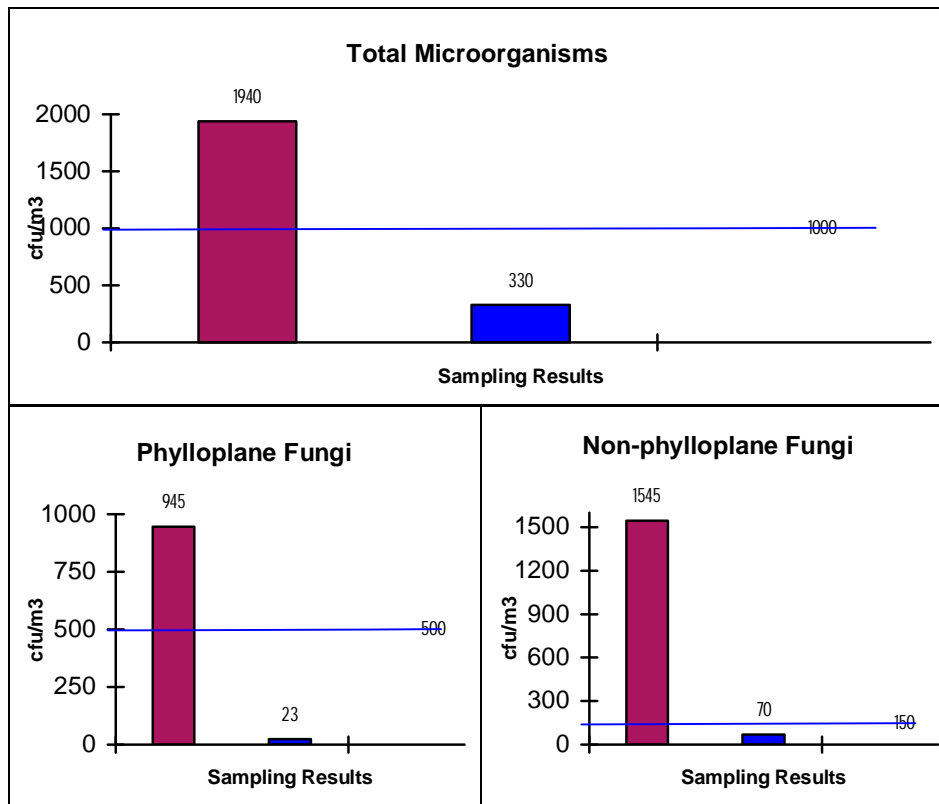
Location 2: Counting Room (INSIDE), Finance Dept. 4<sup>th</sup> Floor.

Colony forming units per cubic meter of Air (cfu/m <sup>3</sup> )	Guideline limit (cfu/m <sup>3</sup> )	Previous results (sample date 4/11/04)	Re-test sampling results (sample date 15/2/06) Readings made 3 wks after Airfree's installation.	Percentage reduction
Total Microorganisms	1000	1940	320	84%
Phylloplane Fungi	500	945	23	98%
Non-phyloplane Fungi	150	1545	70	95%
